Date: 1-1-12

A 33Ah battery near full charge, charged by 40+60 Watt solar panel. The battery is connected to an inverter and it is used to power a laptop.

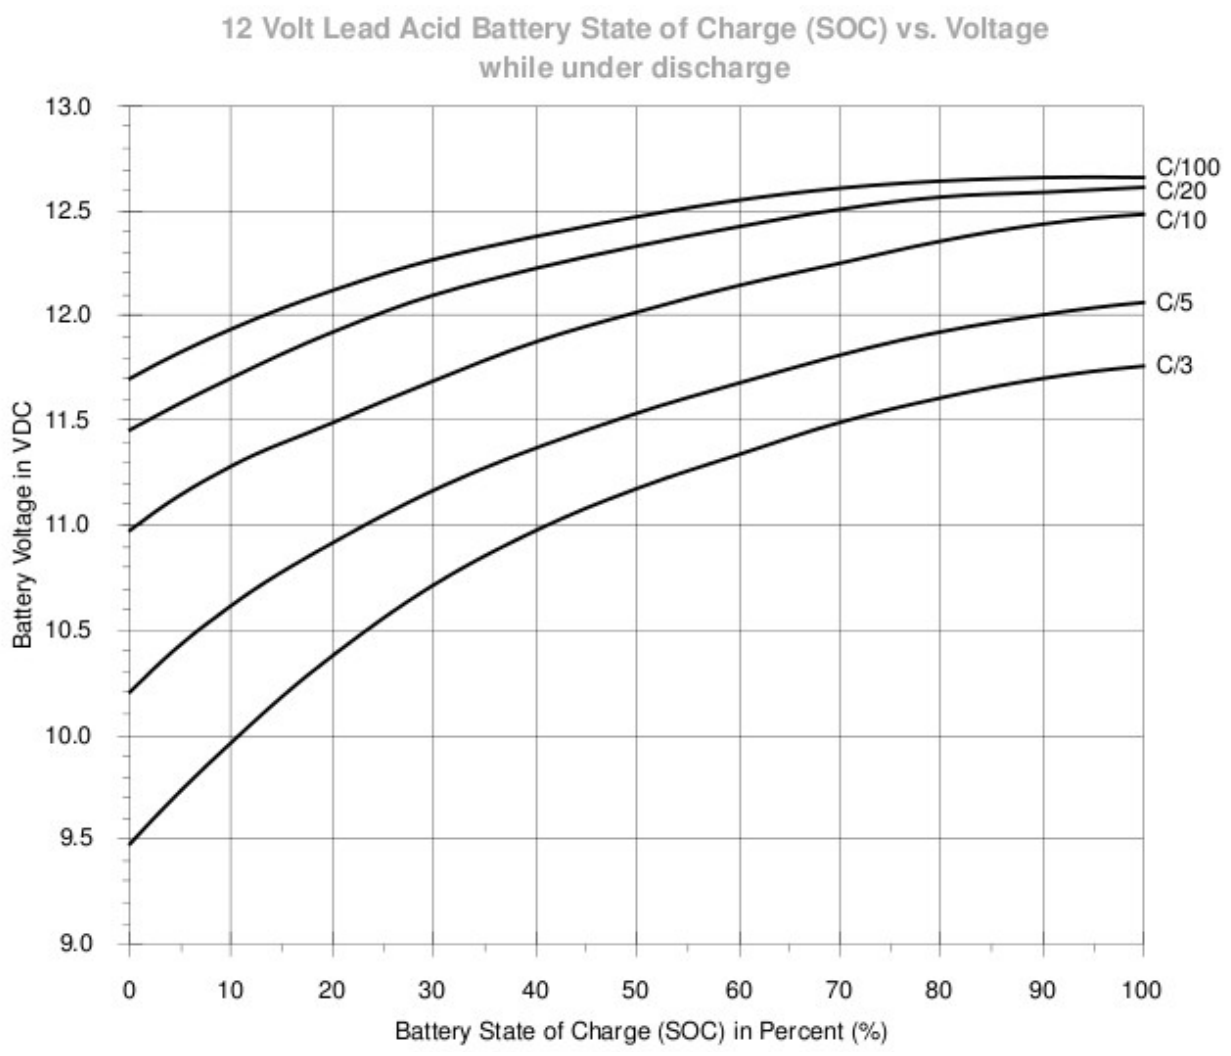
Diagrams and other data:

Discharging the same battery again. with the same faulty and unpredictable inverter. Charged good amount by a sunny sky by 40+60W panels . I think the battery is supplying 2A of current for laptop and 1A for broadband modem. This is assuming a considerable conversion loss in in the inverter side too. But I could be wrong. If it is 3A, it should approximately follow the C/3 curve as shown in the end of this document.
